**Flood Control Project Maintenance
Levee Inspections****LMA District Cover Sheet****Spring 2016 Levee Inspection Results****Sacramento River West Side Levee District**

Spring 2016 Levee Inspection Results

Sacramento River West Side Levee District

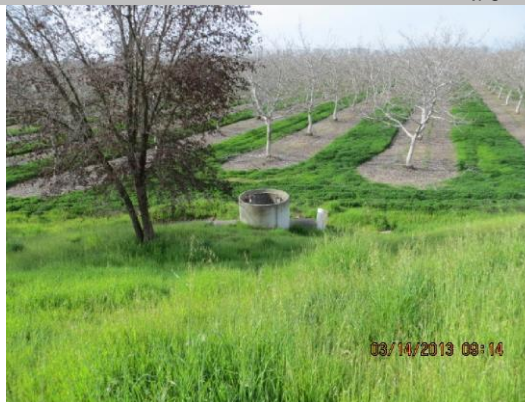
Photo 2 of 2 : UCIP_SP_2016_10261_17465.jpg

Concrete distribution riser on LS toe.

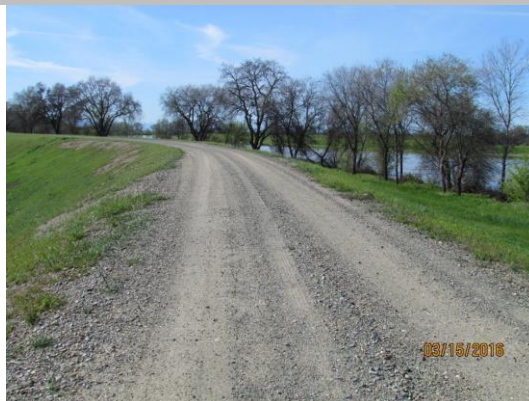
Photo 1 of 1 : SP_2016_NA0016_435_185_20160323_00252.jpg

LM Start	24.54	Rating **	M	Issue No.	185
LM End	24.58	Issue Type +	Ma	Location *	CR
Category	Earthen Levee			GPS Latitude/Longitude	
				Start	End
Item	Crown Surface / Depressions / Rutting			39.005160 °	39.005311 °
				-121.812720 °	-121.813332 °
DWR ID	DWR_NA0016_01_s _ 2016_185				
Comment Code					
C3 : Add appropriate gravel or road base. Grade and compact.					
Inspector Comment

View of the crown of the levee looking upstream. Spring 2016.

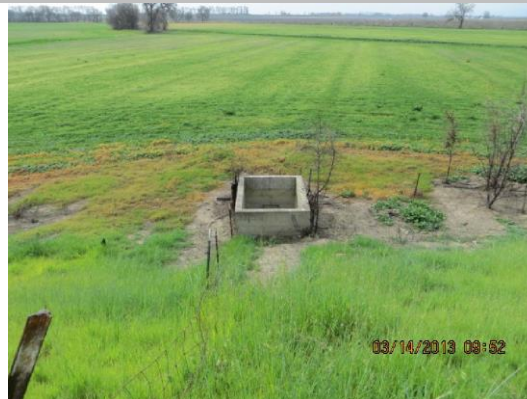
Photo 2 of 2 : UCIP_SP_2016_10265_17485.jpg

LM Start	24.73	Rating **	M	Issue No.	1576 (cont)	
LM End	24.73	Issue Type +	En	Location *	CR	
Category	Supplemental			GPS Latitude/Longitude		
				Start	End	
Item	DWR UCIP Field Study			39.005097 °	39.005097 °	
				-121.816116 °	-121.816116 °	
DWR ID						
Comment Code						
Inspector Comment						
FS_ID:10265						
DS_ID:20251						
EP_NO: 9328						
Repair Type: Non-Urgent						
Crossing Status: Found						
UCIP Comments: Appears abandoned. Needs to be abandoned properly.						
FIELD_STRUCT_DESC: 24-inch corrugated metal pipe through levee 20.0 feet below crown. Slide gate in 36-inch corrugated metal riser unit on the waterward slope. 7'X9' Distribution box at toe of the landward slope (ABO. No. 9328, 1960)						
FS Date: 3/14/2013

7-foot by 9-foot distribution box at LS toe.

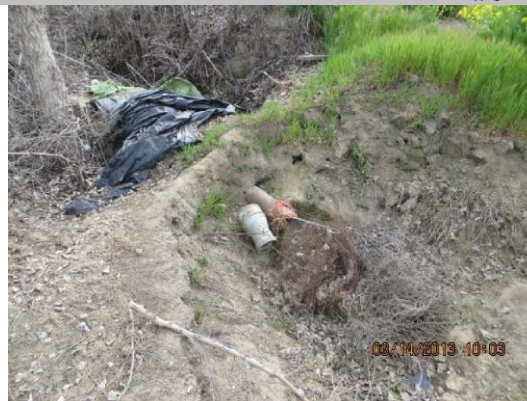
Photo 2 of 2 : UCIP_SP_2016_42860_17492.jpg

LM Start	25.02	Rating **	U	Issue No.	1587 (cont)
LM End	25.02	Issue Type +	En	Location *	CR
Category	Supplemental			GPS Latitude/Longitude	
				Start	End
Item	DWR UCIP Field Study			39.006538 °	39.006538 °
				-121.821058 °	-121.821058 °
DWR ID					
Comment Code					
Inspector Comment					
FS_ID:42860 DS_ID:20339 EP_NO: 9330 Repair Type: Urgent Crossing Status: Found UCIP Comments: Possible sink hole over pipe alignment on WS berm at rivers edge. general condition of pipe and appurtances in disrepair. FIELD_STRUCT_DESC: 10-inch pipe through levee 12.3 feet below crown. 6-inch pipe discharges into 10-inch pipe on waterward end, portable pump and gate valve on waterward side. Power pole and anchor on waterward shoulder and toe (ABO No. 9330, 1960). Originally included in the 1960 O&M manual. FS Date: 3/14/2013

6-inch pipe at LS toe.

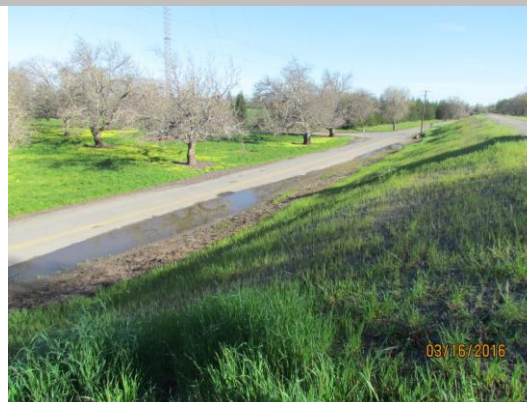
Photo 1 of 1 : SP_2016_NA0016_435_188_20160323_00253.jpg

LM Start	25.70	Rating **	U	Issue No.	188
LM End	25.73	Issue Type +	Ob	Location *	LS
Category	Earthen Levee			GPS Latitude/Longitude	
				Start	End
Item	Seepage / Sandboils			39.013914 °	39.014355 °
				-121.826661 °	-121.826329 °
DWR ID	DWR_NA0016_01_s_2016_188				
Comment Code					
Inspector Comment					
Seems to be seepage through the levee. Appears that no sloughing has occurred. Recommend monitoring this site.

View of the seepage on the landward side of the levee looking upstream. Spring 2016.

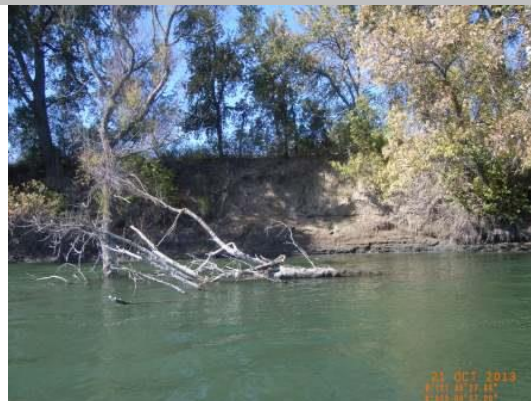
Photo 1 of 1 : SP_2016_NA0016_435_12_20160304_00012.jpg

LM Start	25.75	Rating **	M	Issue No.	12
LM End	25.91	Issue Type +	Ma	Location *	WS
Category	Supplemental			GPS Latitude/Longitude	
				Start	End
Item	2015 USACE Erosion Survey, DRAFT			39.014499 °	39.016401 °
				-121.825880 °	-121.824230 °
DWR ID	DWR_NA0016_01_s _ 2016_12				
Comment Code					
Inspector Comment					
2008 - Whole bank is eroding, nearly vertical slope with cohesive toe. Bed is very deep along the toe (greater than 30 ft deep at 20 ft from the shore). 2011 - Some new minor erosion. 2015: No observed changes. [2015 Site ID: SAC_118-0_R]

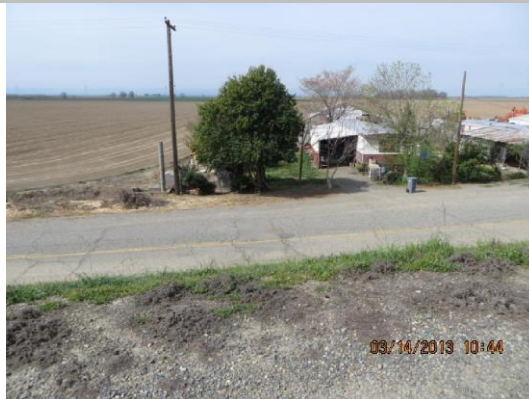
Photo 1 of 2 : UCIP_SP_2016_10285_17532.jpg

LM Start	26.46	Rating **	M	Issue No.	1555
LM End	26.46	Issue Type +	En	Location *	LS
Category	Supplemental			GPS Latitude/Longitude	
				Start	End
Item	DWR UCIP Field Study			39.023842 °	39.023842 °
				-121.823077 °	-121.823077 °
DWR ID					
Comment Code					
Inspector Comment					
FS_ID:10285					
DS_ID:20253					
EP_NO: 9136					
Repair Type: Non-Urgent					
Crossing Status: Found					
UCIP Comments: Pipe appears to be abandoned. Pipe needs to be abandoned properly.					
FIELD_STRUCT_DESC: 18-inch steel pipe through levee 3.0 feet below crown. Steel cutoff wall at centerline. Air release valve on the waterward shoulder (Permit No. 9136, 1974). Slide gate in 72-inch diameter CMP riser on LS toe.					
FS Date: 3/14/2013

72-inch CMP riser on LS toe under JP next to tree.

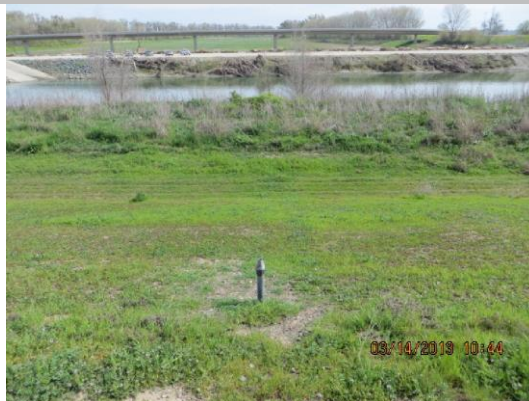
Photo 2 of 2 : UCIP_SP_2016_10285_17531.jpg

Air release valve on WS shoulder.

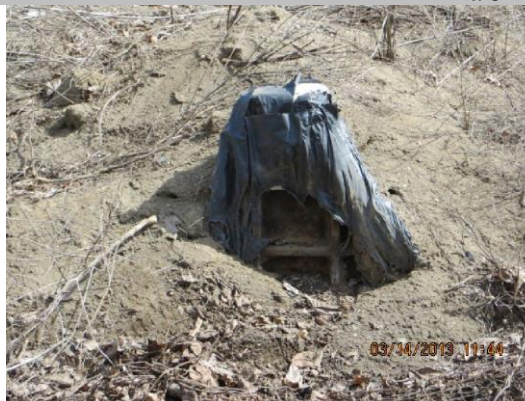
Photo 2 of 2 : UCIP_SP_2016_10291_17547.jpg

LM Start	27.54	Rating **	M	Issue No.	1559 (cont)	
LM End	27.54	Issue Type +	En	Location *	CR	
Category	Supplemental			GPS Latitude/Longitude		
				Start	End	
Item	DWR UCIP Field Study			39.034870 °	39.034870 °	
				-121.833501 °	-121.833501 °	
DWR ID						
Comment Code						
Inspector Comment						
FS_ID:10291 DS_ID:20257 EP_NO: 9355 Repair Type: Non-Urgent Crossing Status: Found UCIP Comments: Pipe needs to be properly abandoned. FIELD_STRUCT_DESC: 24-inch steel pipe through levee 14.0 feet below crown. Slide gate on the waterward end, gate valve on the landward end (ABO No. 9355, 1960). Originally included in the 1960 O&M manual. FS Date: 3/14/2013

Gate valve buried on LS toe.

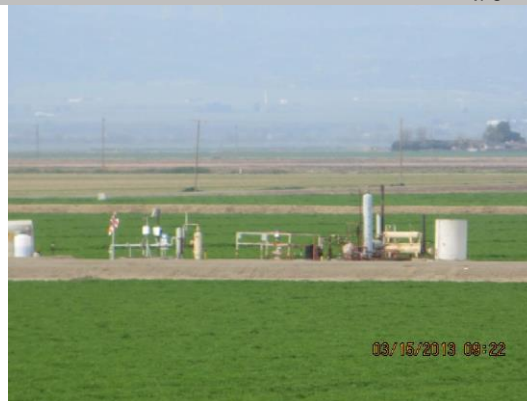
Photo 1 of 1 : UCIP_SP_2016_41839_17563.jpg

LM Start	28.61	Rating **	U	Issue No.	1588
LM End	28.61	Issue Type +	En	Location *	LS
Category	Supplemental			GPS Latitude/Longitude	
				Start	End
Item	DWR UCIP Field Study			39.047758 °	39.047758 °
				-121.840914 °	-121.840914 °
DWR ID					
Comment Code					
Inspector Comment					
FS_ID:41839 DS_ID:20319 EP_NO: 16632 Repair Type: Urgent Crossing Status: Indicator Found UCIP Comments: No gasoline markers on either side of levee. FIELD_STRUCT_DESC: 4-inch natural gas pipeline through levee 62.0 feet below crown. Crosses channel (Permit No. 16632, 1999). Gas well visible 1500-feet west of levee. FS Date: 3/15/2013

gas well 1500-feet west of this location.

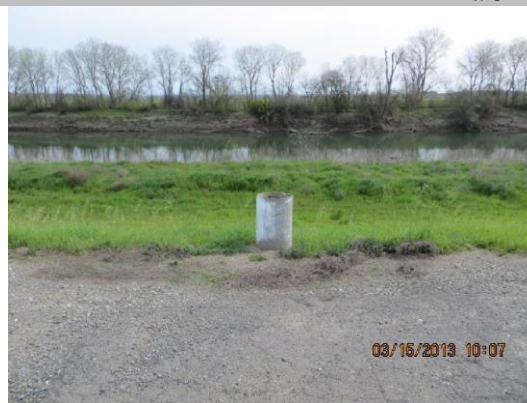
Photo 1 of 2 : UCIP_SP_2016_10324_17587.jpg

LM Start	28.78	Rating **	U	Issue No.	1560
LM End	28.78	Issue Type +	En	Location *	LS
Category	Supplemental			GPS Latitude/Longitude	
				Start	End
Item	DWR UCIP Field Study			39.050186 °	39.050186 °
				-121.841553 °	-121.841553 °
DWR ID					
Comment Code					
Inspector Comment					
FS_ID:10324					
DS_ID:20311					
EP_NO: 12609					
Repair Type: Urgent					
Crossing Status: Found					
UCIP Comments: Flap gate missing from waterward end of pipe.					
FIELD_STRUCT_DESC: 24-inch steel outfall pipe through levee 4.1					
feet below crown. Siphon breaker in 18-inch concrete riser on WS					
shoulder. Flap gate on discharge end of pipe 130 feet waterward of the					
centerline of the levee at elevation 41.5 feet, USED Datum, and the					
riverbank has rock protection at this location (Permit No. 12609, 1979).					
FS Date: 3/15/2013

18-inch concrete riser on WS shoulder.

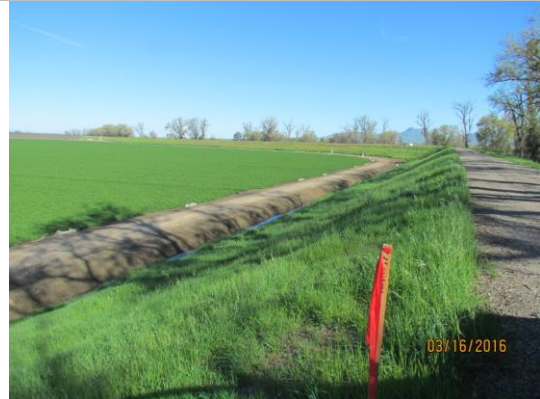
Photo 1 of 2 : SP_2016_NA0016_435_197_20160323_00257.jpg

LM Start	29.58	Rating **	U	Issue No.	197
LM End	29.66	Issue Type +	Ob	Location *	LS
Category	Earthen Levee			GPS Latitude/Longitude	
				Start	End
Item	Seepage / Sandboils			39.061709 °	39.062799 °
				-121.839838 °	-121.839564 °
DWR ID	DWR_NA0016_01_s _ 2016_197				
Comment Code					
Inspector Comment					
Seepage area has been staked and noted by LMA. Monitor seepage site.

View of the seepage into the ditch on the landward side of the levee looking upstream. Spring 2016.

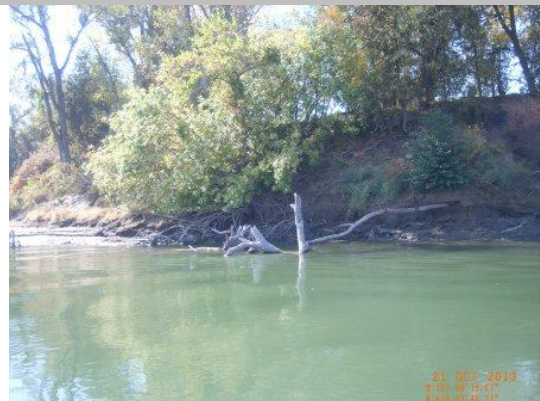
Photo 1 of 1 : SP_2016_NA0016_435_2_20160304_00002.jpg

LM Start	29.69	Rating **	A/W	Issue No.	2
LM End	29.73	Issue Type +	Ma	Location *	WS
Category	Supplemental			GPS Latitude/Longitude	
				Start	End
Item	2015 USACE Erosion Survey, DRAFT			39.063209 °	39.063997 °
				-121.838927 °	-121.839335 °
DWR ID	DWR_NA0016_01_s _ 2016_2				
Comment Code					
Inspector Comment					
1997 - Mass failure of the lower cohesive bank and toe. 2000 - Still eroding, steeply dipping foresets in the toe are falling off. 2010 - Some new erosion and some new deposition. Eddy current off the upstream rock. 2011 - Still plenty of berm left. 2015: No observed changes. [2015 Site ID: SAC_122-0_R]

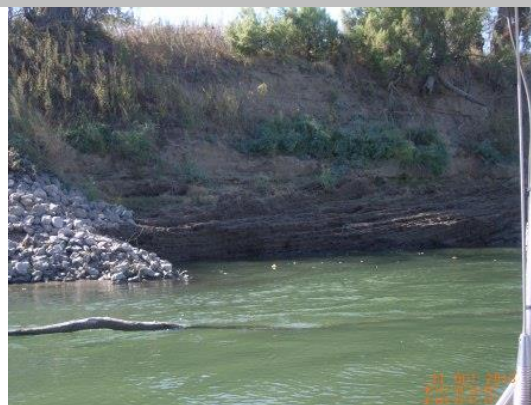
Photo 1 of 1 : SP_2016_NA0016_435_13_20160304_00013.jpg

LM Start	29.96	Rating **	M	Issue No.	13
LM End	30.00	Issue Type +	Ma	Location *	WS
Category	Supplemental			GPS Latitude/Longitude	
				Start	End
Item	2015 USACE Erosion Survey, DRAFT			39.065886 °	39.066287 °
				-121.842950 °	-121.843602 °
DWR ID	DWR_NA0016_01_s _ 2016_13				
Comment Code					
Inspector Comment					
2002 - Upstream end has recent slope failure and exposure of tree roots. 2003 - Some new minor slope erosion with new snags on the bank. 2004 - Appears a little worse. 2005 - Scallop in bank at the upstream end looks worse. 2009 - Minimal new erosion, Berm width is still large, but one large event or one fallen tree and it could go fast. 2010 - New erosion, bank is nearly all vertical from slumping. Site looks bad. 2011 - Site continues to look bad. 2012 - Minor new erosion. 2015: Undermining of toe rock. [2015 Site ID: SAC_122-3_R]

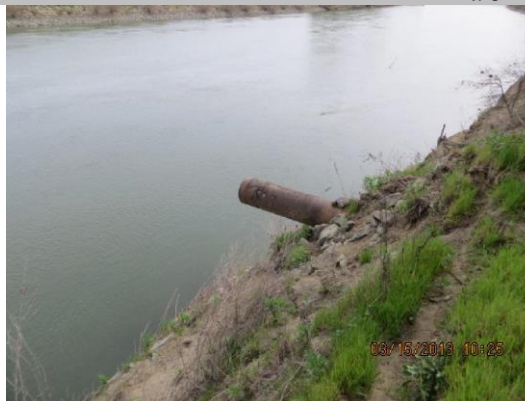
Photo 1 of 2 : UCIP_SP_2016_10325_17591.jpg

LM Start	30.08	Rating **	M	Issue No.	1561
LM End	30.08	Issue Type +	En	Location *	WS
Category	Supplemental			GPS Latitude/Longitude	
				Start	End
Item	DWR UCIP Field Study			39.066749 °	39.066749 °
				-121.844987 °	-121.844987 °
DWR ID					
Comment Code					
Inspector Comment					
FS_ID:10325 DS_ID:20317 EP_NO: 14495 Repair Type: Non-Urgent Crossing Status: Found UCIP Comments: Pipe may need flap gate at water side. FIELD_STRUCT_DESC: 22-inch steel storm drain pipe through levee 3.8 feet below crown. Pipe extends from existing pumphouse located at the landward toe through the levee to the low water channel Siphon breaker in 24-inch CMP riser on LS shoulder. (Permit No. 14495, 1987). Replaced 12-inch and 16-inch pipes installed under Permit No. 9358. FS Date: 3/15/2013

24-inch pipe at rivers edge

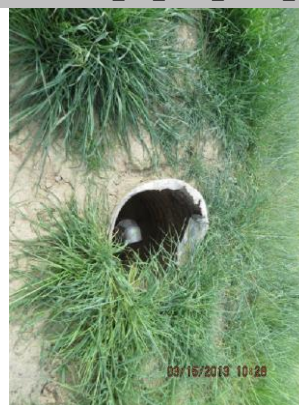
Photo 2 of 2 : UCIP_SP_2016_10325_17590.jpg

Siphon breaker in 24-inch cmp on LS shoulder.

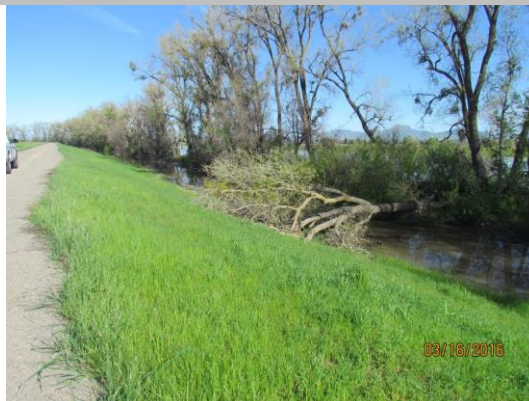
Photo 1 of 1 : SP_2016_NA0016_435_199_20160323_00260.jpg

LM Start	30.15	Rating **	M	Issue No.	199	
LM End	30.15	Issue Type +	Ma	Location *	WS	
Category	Earthen Levee			GPS Latitude/Longitude		
				Start		End
Item	Encroachments			39.067426 °		39.067426 °
				-121.845928 °		-121.845928 °
DWR ID	DWR_NA0016_01_s _ 2016_199					
Comment Code						
TR : Tree or limb						
Inspector Comment

View of the fallen tree on the waterward side of the levee looking upstream. Spring 2016.

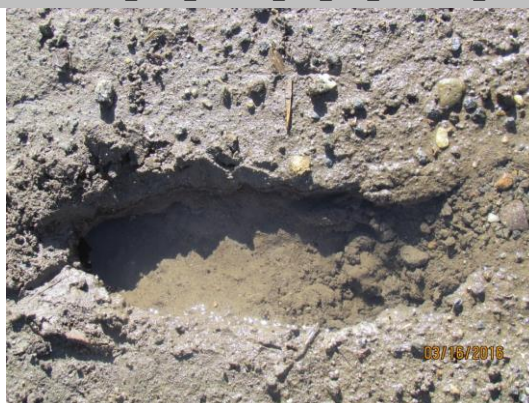
Photo 1 of 3 : SP_2016_NA0016_435_201_20160328_00265.jpg

LM Start	30.24	Rating **	U	Issue No.	201
LM End	30.24	Issue Type +	Ob	Location *	LS
Category	Earthen Levee			GPS Latitude/Longitude	
				Start	End
Item	Seepage / Sandboils			39.068480 °	39.068480 °
				-121.847061 °	-121.847061 °
DWR ID	DWR_NA0016_01_s _ 2016_201				
Comment Code					
Inspector Comment					
Boil has clear water running through. Continue to monitor

Boil has clear water running through. Spring 2016.

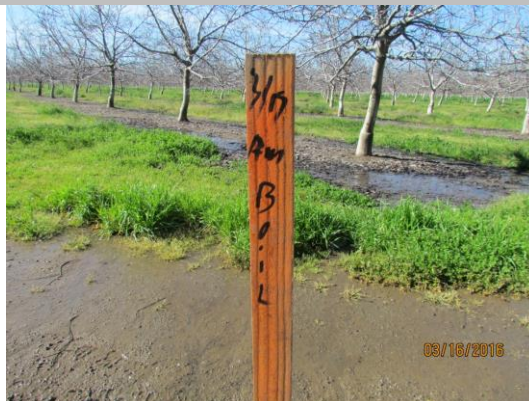
Photo 3 of 3 : SP_2016_NA0016_435_201_20160328_00264.jpg

LM Start	30.24	Rating **	U	Issue No.	201 (cont)	
LM End	30.24	Issue Type +	Ob	Location *	LS	
Category	Earthen Levee			GPS Latitude/Longitude		
				Start		End
Item	Seepage / Sandboils			39.068480 °		39.068480 °
				-121.847061 °		-121.847061 °
DWR ID	DWR_NA0016_01_s _ 2016_201					
Comment Code						
Inspector Comment						
Boil has clear water running through. Continue to monitor

Monitoring stake was placed on 3/15/16. Spring 2016.

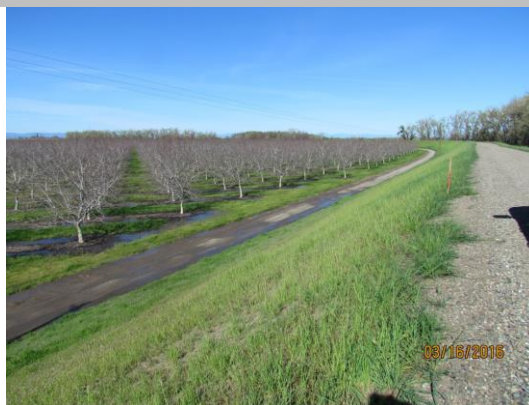
Photo 1 of 2 : SP_2016_NA0016_435_200_20160323_00261.jpg

LM Start	30.25	Rating **	U	Issue No.	200
LM End	30.25	Issue Type +	Ob	Location *	LS
Category	Earthen Levee			GPS Latitude/Longitude	
				Start	End
Item	Seepage / Sandboils			39.068542 °	39.068542 °
				-121.847131 °	-121.847131 °
DWR ID	DWR_NA0016_01_s _ 2016_200				
Comment Code					
Inspector Comment					
LMA has stakes on the levee monitoring seepage site.

View of the seepage on the landward side of the levee looking upstream. Spring 2016.

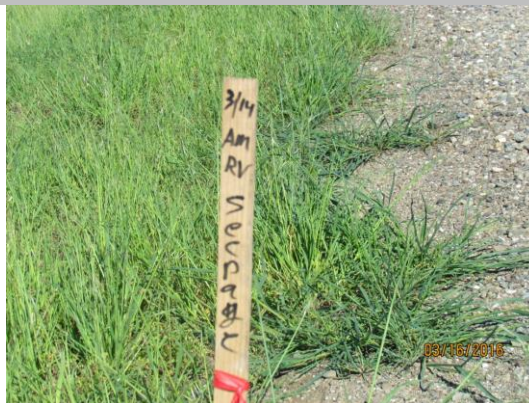
Photo 2 of 2 : SP_2016_NA0016_435_200_20160323_00263.jpg

Stake is used to monitor seepage. Spring 2016.

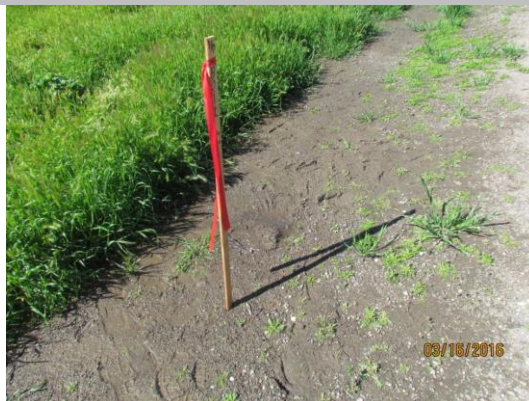
Photo 1 of 3 : SP_2016_NA0016_435_202_20160328_00267.jpg

LM Start	30.46	Rating **	A	Issue No.	202
LM End	30.46	Issue Type +	Ob	Location *	LS
Category	Earthen Levee			GPS Latitude/Longitude	
				Start	End
Item	Seepage / Sandboils			39.070673 °	39.070673 °
				-121.849935 °	-121.849935 °
DWR ID	DWR_NA0016_01_s _ 2016_202				
Comment Code					
Inspector Comment					
Sandboil about 2 inches wide is spitting out material. LMA has sandbagged the boil.

View of the monitoring stake and boil at the toe of the levee on the landward side. Spring 2016.

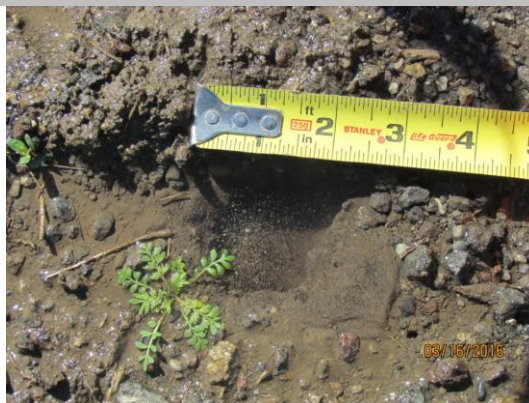
Photo 2 of 3 : SP_2016_NA0016_435_202_20160328_00268.jpg

Boil is about 2 inches wide. Spring 2016.

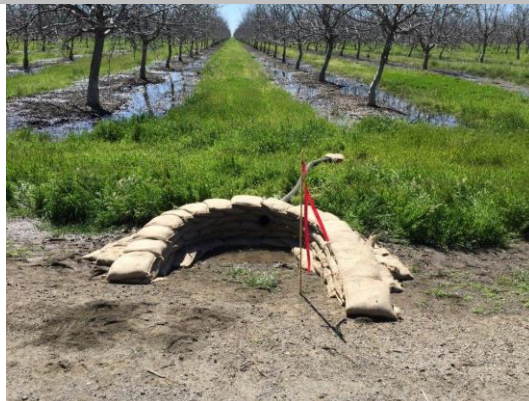
Photo 3 of 3 : SP_2016_NA0016_435_202_20160328_00269.jpg

LMA has constructed sack ring around the boil and will continue to monitor it. Spring 2016.

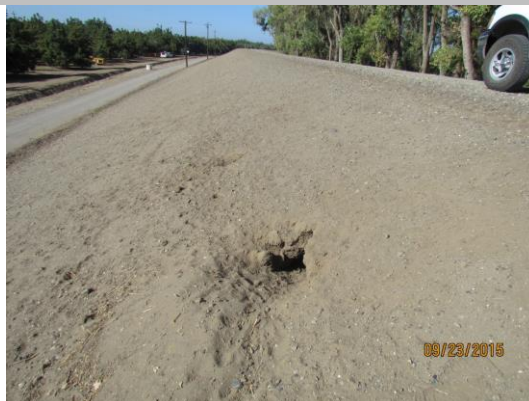
Photo 1 of 1 : SP_2016_NA0016_435_135_20160304_00071.jpg

LM Start	30.86	Rating **	M	Issue No.	135
LM End	30.86	Issue Type +	Ma	Location *	LS
Category	Earthen Levee			GPS Latitude/Longitude	
				Start	End
Item	Animal Control			39.068482 °	39.068482 °
				-121.856639 °	-121.856639 °
DWR ID	DWR_NA0016_01_f_2015_135				
Comment Code					
A3 : No rodents visible, but rodent burrows visible; need to backfill and compact or grout burrows.					
Inspector Comment

View of the rodent hole on the landward side of the levee looking upstream. Fall 2015.

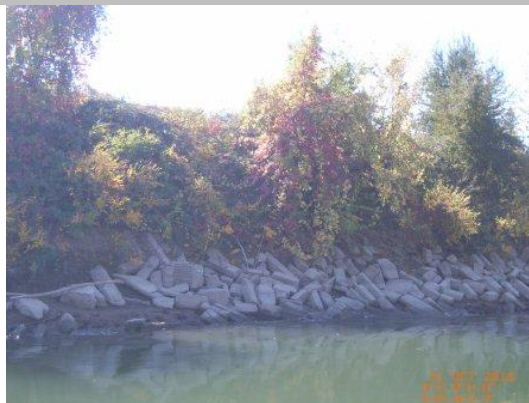
Photo 1 of 1 : SP_2016_NA0016_435_17_20160304_00017.jpg

LM Start	31.43	Rating **	M	Issue No.	17
LM End	31.45	Issue Type +	Ma	Location *	WS
Category	Supplemental			GPS Latitude/Longitude	
				Start	End
Item	2015 USACE Erosion Survey, DRAFT			39.067004 °	39.066901 °
				-121.866913 °	-121.867322 °
DWR ID	DWR_NA0016_01_s_2016_17				
Comment Code					
Inspector Comment					
1997 - Erosion into the levee section; old concrete rubble loss at toe; transition between the rock upstream and the cobble downstream. 2000 - Cohesive bench with concrete slabs on top; 25 ft deep scour hole on the downstream end. 2015: No observed changes. [2015 Site ID: SAC_123-7_R]

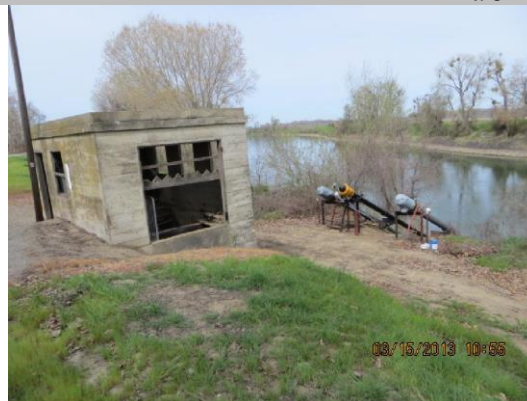
Photo 1 of 2 : UCIP_SP_2016_11543_18942.jpg

Comment Code					
Inspector Comment					
FS_ID:11543 DS_ID:20262 EP_NO: 9338 Repair Type: Non-Urgent Crossing Status: Found UCIP Comments: Pipe leaking at intake pipe on rivers edge below pump FIELD_STRUCT_DESC: 24-inch steel pipe through levee 24.0 feet below crown (ABO No. 9338, 1960). Slide gate in abandoned concrete pump house on the waterward slope. Three slant pumps mounted on pile structure on the waterward bank. 30-inch concrete pipe under the highway on the landside. 48-inch steel riser on the landside of highway. Overhead high tower power line crosses the levee. Power line has been run underground to service box on waterward shoulder at L.M. 32.01. Ramps on both slopes. Originally included in the 1960 O&M manual. FS Date: 3/15/2013

Concrete block house with slide gate inside.

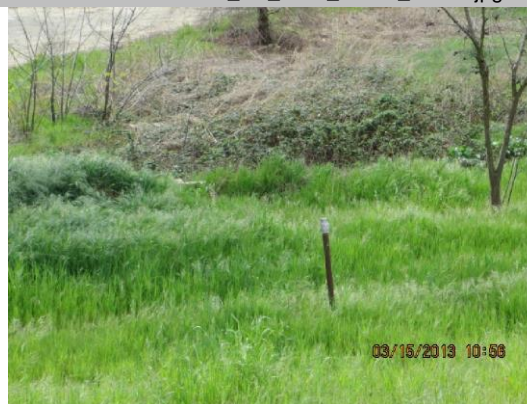
Photo 2 of 2 : UCIP_SP_2016_11543_18941.jpg

Siphon breaker on LS toe.

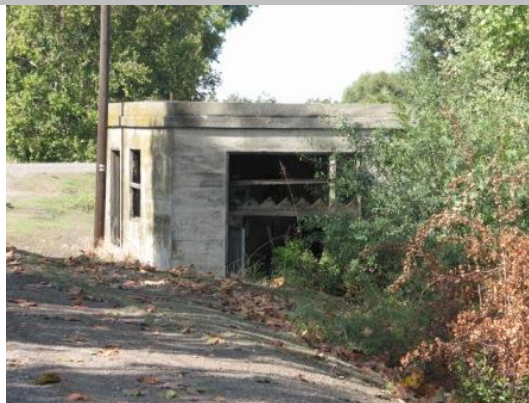
Photo 1 of 1 : SP_2016_NA0016_435_60_20160304_00034.jpg

LM Start	31.63	Rating **	M	Issue No.	60
LM End	31.63	Issue Type +	En	Location *	WS
Category	Earthen Levee			GPS Latitude/Longitude	
				Start	End
Item	Encroachments			39.066147 °	39.066147 °
				-121.870425 °	-121.870425 °
DWR ID	DWR_NA0016_01_s _ 2012_60				
Comment Code					
BU : Building					
Inspector Comment					
Old concrete pumphouse on shoulder open needs to be sealed up.

Old concrete pump house on the waterside levee slope. Fall 2011.

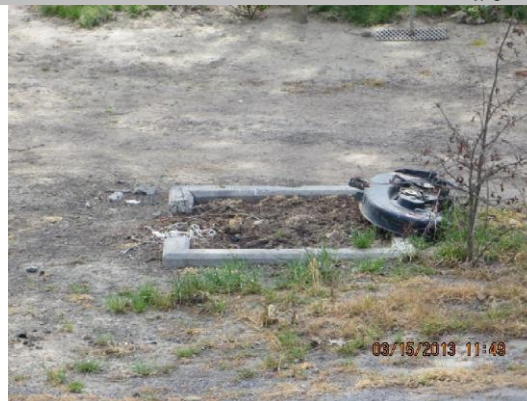
Photo 2 of 2 : UCIP_SP_2016_10364_17644.jpg

LM Start	32.27	Rating **	M	Issue No.	1564 (cont)	
LM End	32.27	Issue Type +	En	Location *	CR	
Category	Supplemental			GPS Latitude/Longitude		
				Start	End	
Item	DWR UCIP Field Study			39.069857 °	39.069857 °	
				-121.880923 °	-121.880923 °	
DWR ID						
Comment Code						
Inspector Comment						
FS_ID:10364						
DS_ID:20304						
EP_NO: 9374						
Repair Type: Non-Urgent						
Crossing Status: Found						
UCIP Comments: Need to verify type of abandonment						
FIELD_STRUCT_DESC: 2 of 4: *Abandoned* 4-inch pipe through levee						
6.5 feet below crown. Gate valve on the waterward end. Siphon breaker						
in 24-inch corrugated metal riser unit on the landward slope. 4X4-						
concrete distribution box on south side of highway 45 at LS toe. (ABO						
No. 9374, 1960). Originally included in the 1960 O&M manual.						
FS Date: 3/15/2013

4X4 concrete box off LS toe.

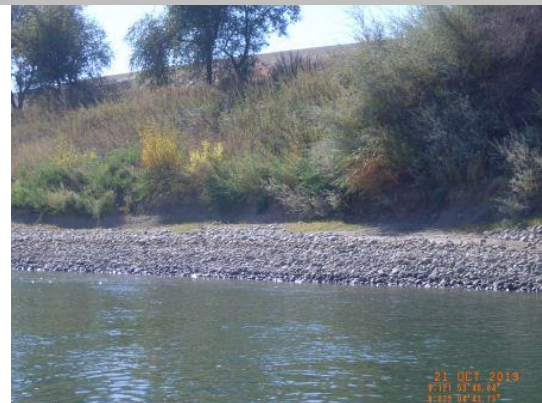
Photo 1 of 1 : SP_2016_NA0016_435_5_20160304_00005.jpg

LM Start	33.29	Rating **	M	Issue No.	5
LM End	33.37	Issue Type +	Ma	Location *	WS
Category	Supplemental			GPS Latitude/Longitude	
				Start	End
Item	2015 USACE Erosion Survey, DRAFT			39.078340 °	39.079351 °
				-121.894656 °	-121.895317 °
DWR ID	DWR_NA0016_01_s _ 2016_5				
Comment Code					
Inspector Comment					
2008 - Slow erosion of the hard toe. 2010 - Cobble rubble is failing, erosion is into the toe of the levee, with vertical slumping. 2012 - Site appears to be relatively stable. 2013 - New animal holes. 2015: No observed changes. [2015 Site ID: SAC_125-6_R]

USACE 2013 Photo #1

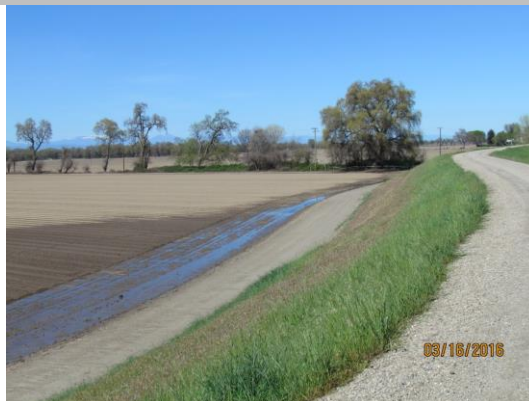
Photo 1 of 1 : SP_2016_NA0016_435_207_20160328_00270.jpg

LM Start	33.78	Rating **	U	Issue No.	207
LM End	33.85	Issue Type +	Ob	Location *	LS
Category	Earthen Levee			GPS Latitude/Longitude	
				Start	End
Item	Seepage / Sandboils			39.084393 °	39.085184 °
				-121.894522 °	-121.895354 °
DWR ID	DWR_NA0016_01_s _ 2016_207				
Comment Code					
Inspector Comment					
Seepage site is being monitored by the LMA.

View of the seepage on the landward side of the levee looking upstream.
Spring 2016.

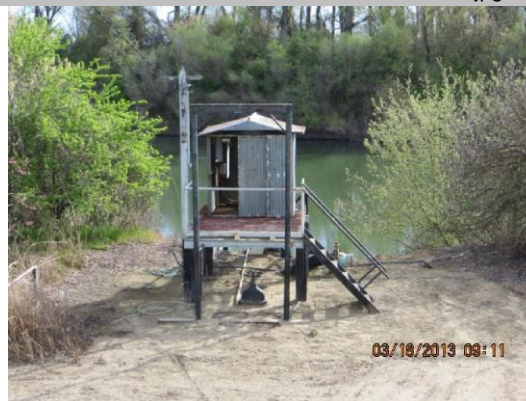
Photo 1 of 2 : UCIP_SP_2016_10403_17662.jpg

LM Start	34.00	Rating **	M	Issue No.	1565
LM End	34.00	Issue Type +	En	Location *	WS
Category	Supplemental			GPS Latitude/Longitude	
				Start	End
Item	DWR UCIP Field Study			39.087072 °	39.087072 °
				-121.896464 °	-121.896464 °
DWR ID					
Comment Code					
Inspector Comment					
FS_ID:10403 DS_ID:20268 EP_NO: 9364A Repair Type: Non-Urgent Crossing Status: Found UCIP Comments: Pipe rusted through at concrete distribution box. May be indicator of pipe condition through levee. FIELD_STRUCT_DESC: 1 of 4: 16-inch steel pipe through levee 6.3 feet below crown (ABO No. 9364A, 1945). Pump in pump house on the waterward end. Siphon breaker in 36-inch steel riser unit on the landward slope. Discharges into 5X9 Concrete distribution box at LS toe. Installed by United States Army Corp of Engineers, 1945. Included in the 1960 O&M manual. FS Date: 3/18/2013

Pump at WS berm.

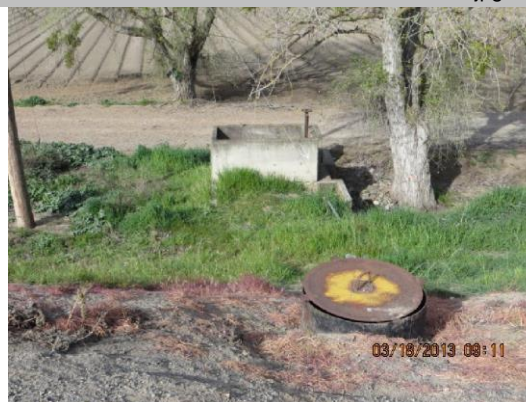
Photo 2 of 2 : UCIP_SP_2016_10403_17661.jpg

siphon breaker in 36-inch steel riser on LS slope with concrete distribution box on LS toe.

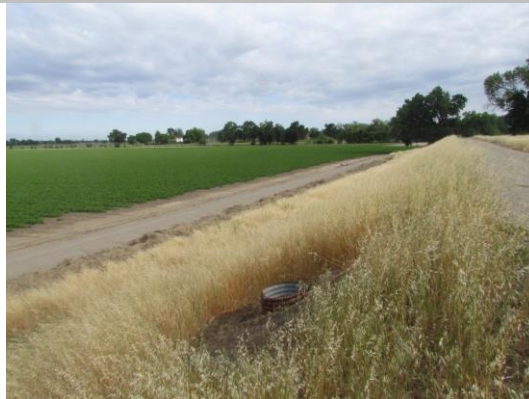
Photo 1 of 1 : SP_2016_NA0016_435_100_20160304_00052.jpg

LM Start	34.01	Rating **	M	Issue No.	100
LM End	34.07	Issue Type +	En	Location *	LS
Category	Earthen Levee			GPS Latitude/Longitude	
				Start	End
Item	Encroachments			39.087176 °	39.088099 °
				-121.896480 °	-121.896498 °
DWR ID	DWR_NA0016_01_s _ 2015_100				
Comment Code					
DT : Ditch					
Inspector Comment

View of the ditch at the landward side of the levee looking upstream. Spring 2015.

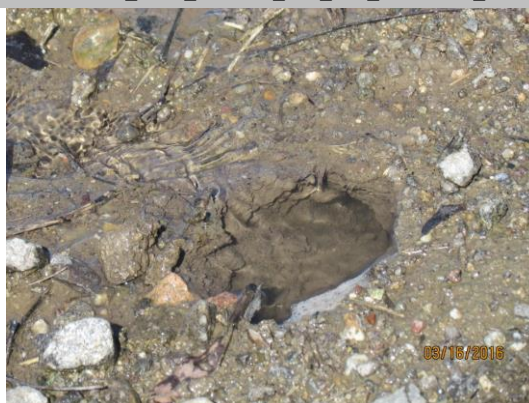
Photo 1 of 2 : SP_2016_NA0016_435_208_20160328_00273.jpg

LM Start	34.15	Rating **	U	Issue No.	208
LM End	34.15	Issue Type +	Ob	Location *	LS
Category	Earthen Levee			GPS Latitude/Longitude	
				Start	End
Item	Seepage / Sandboils			39.089243 °	39.089243 °
				-121.896262 °	-121.896262 °
DWR ID	DWR_NA0016_01_s _ 2016_208				
Comment Code					
Inspector Comment					
Clear water. Boil about 5 inches wide. Also a seepage area.

Boil has clear water coming out of the hole. Spring 2016.

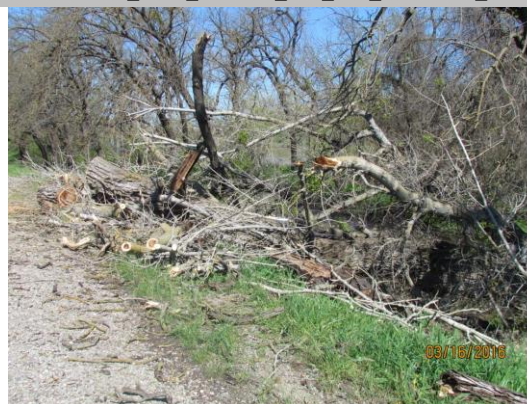
Photo 1 of 1 : SP_2016_NA0016_435_138_20160328_00274.jpg

LM Start	35.22	Rating **	U	Issue No.	138
LM End	35.22	Issue Type +	Ma	Location *	WS
Category	Earthen Levee			GPS Latitude/Longitude	
				Start	End
Item	Encroachments			39.099225 °	39.099225 °
				-121.904326 °	-121.904326 °
DWR ID	DWR_NA0016_01_f_2015_138				
Comment Code					
TR : Tree or limb					
Inspector Comment

View of the fallen tree on the waterward side of the levee looking upstream. Spring 2016.

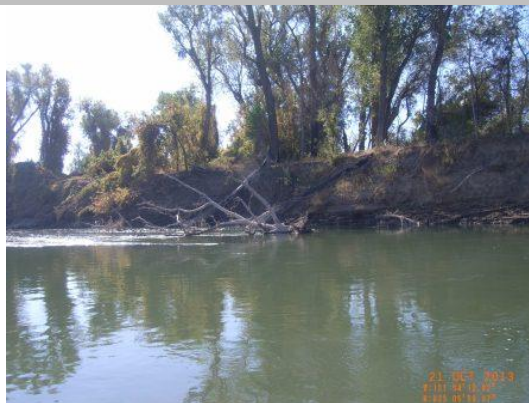
Photo 1 of 1 : SP_2016_NA0016_435_1_20160304_00001.jpg

LM Start	35.23	Rating **	A/W	Issue No.	1
LM End	35.33	Issue Type +	Ma	Location *	WS
Category	Supplemental			GPS Latitude/Longitude	
				Start	End
Item	2015 USACE Erosion Survey, DRAFT			39.099482 °	39.100836 °
				-121.903430 °	-121.904320 °
DWR ID	DWR_NA0016_01_s_2016_1				
Comment Code					
Inspector Comment					
1997 - Major scour off the downstream end of existing rock, creating a scour pocket where the levee starts diverging from the bankline. 2000 - Some minor erosion, 20 ft deep hole at downstream end. 2004 - Small amount of new erosion. 2010 - Bad transition off downstream end of rock revetment, some new erosion. 2012 - Site extended downstream, minor new erosion. 2013- Minor new erosion. 2015: No observed changes. [2015 Site ID: SAC_127-9_R]

USACE 2013 Photo #1

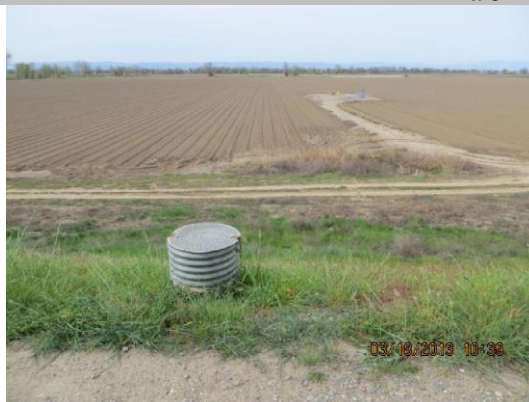
Photo 1 of 1 : UCIP_SP_2016_10424_17700.jpg

LM Start	35.56	Rating **	M	Issue No.	1572
LM End	35.56	Issue Type +	En	Location *	WS
Category	Supplemental			GPS Latitude/Longitude	
				Start	End
Item	DWR UCIP Field Study			39.103533 °	39.103533 °
				-121.906814 °	-121.906814 °
DWR ID					
Comment Code					
Inspector Comment					
FS_ID:10424					
DS_ID:20273					
EP_NO: 9364A					
Repair Type: Non-Urgent					
Crossing Status: Found					
UCIP Comments: Need to verify type of abandonment.					
FIELD_STRUCT_DESC: 3 of 4: 18-inch steel pipe through levee 16.0 feet below crown. Metal cutoff wall. Gate valve on the waterward bank. Siphon breaker in 24-inch corrugated metal riser unit on the landward shoulder. (ABO No. 9364A, 1960). Originally included in the 1960 O&M manual.					
FS Date: 3/18/2013

Siphon breaker in 24-inch CMP riser on LS shoulder.

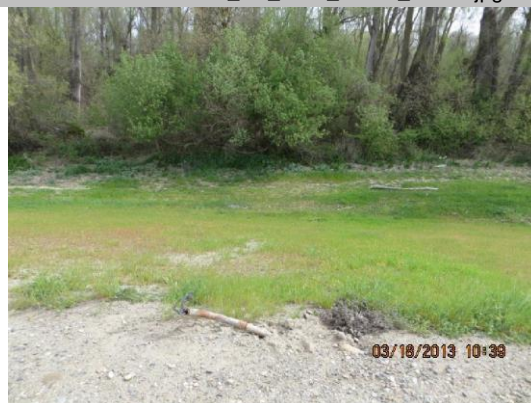
Photo 1 of 2 : UCIP_SP_2016_10425_17702.jpg

LM Start	35.56	Rating **	M	Issue No.	1573
LM End	35.56	Issue Type +	En	Location *	WS
Category	Supplemental			GPS Latitude/Longitude	
				Start	End
Item	DWR UCIP Field Study			39.103533 °	39.103533 °
				-121.906814 °	-121.906814 °
DWR ID					
Comment Code					
Inspector Comment					
FS_ID:10425 DS_ID:20398 EP_NO: 9364 Repair Type: Non-Urgent Crossing Status: Found UCIP Comments: Remove abandoned pipe from levee. FIELD_STRUCT_DESC: 4 of 4: *Abandoned* 1.25-inch conduit through levee 3.0 feet below crown (ABO No. 9364A). FS Date: 3/18/2013

Electrical conduit on WS shoulder.

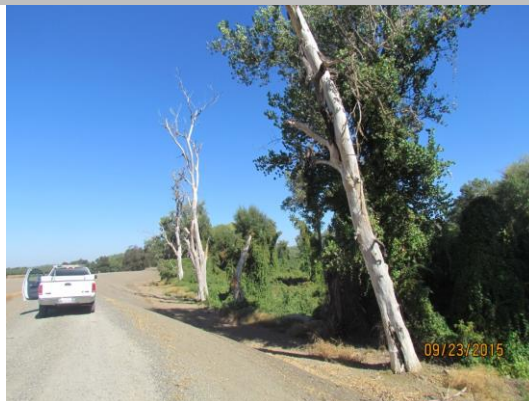
Photo 1 of 1 : SP_2016_NA0016_435_139_20160304_00076.jpg

LM Start	35.69	Rating **	A/W	Issue No.	139
LM End	35.69	Issue Type +	Ma	Location *	WS
Category	Earthen Levee			GPS Latitude/Longitude	
				Start	End
Item	Vegetation			39.105381 °	39.105381 °
				-121.907770 °	-121.907770 °
DWR ID	DWR_NA0016_01_f_2015_139				
Comment Code					
V7 : Trees / Woody Vegetation					
Inspector Comment

View of the dying tree on the waterward side of the levee looking upstream. Fall 2015.

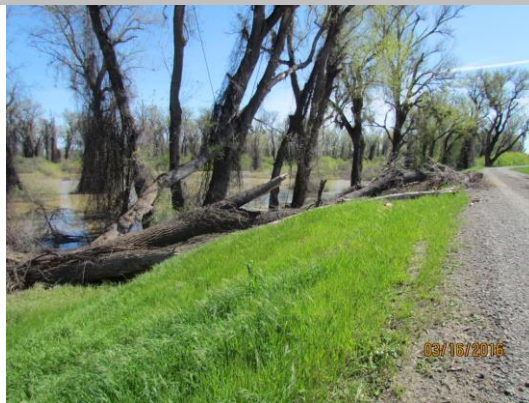
Photo 1 of 1 : SP_2016_NA0016_435_140_20160328_00275.jpg

LM Start	35.86	Rating **	U	Issue No.	140
LM End	35.86	Issue Type +	En	Location *	WS
Category	Earthen Levee			GPS Latitude/Longitude	
				Start	End
Item	Encroachments			39.107611 °	39.107611 °
				-121.908817 °	-121.908817 °
DWR ID	DWR_NA0016_01_f_2015_140				
Comment Code					
TR : Tree or limb					
Inspector Comment

View of the fallen tree on the landward side of the levee looking downstream. Spring 2016.

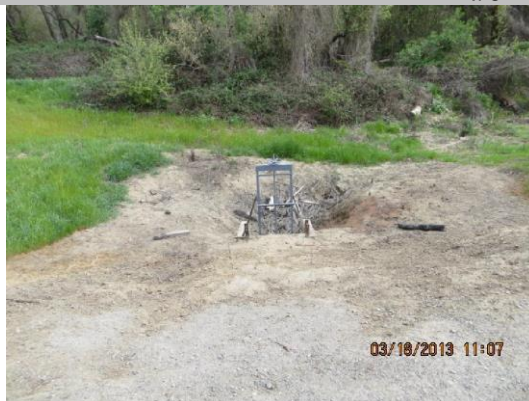
Photo 1 of 2 : UCIP_SP_2016_10426_17705.jpg

LM Start	36.15	Rating **	M	Issue No.	1574
LM End	36.15	Issue Type +	En	Location *	WS
Category	Supplemental			GPS Latitude/Longitude	
				Start	End
Item	DWR UCIP Field Study			39.111233 °	39.111233 °
				-121.911450 °	-121.911450 °
DWR ID					
Comment Code					
Inspector Comment					
FS_ID:10426 DS_ID:20345 EP_NO: 9374 Repair Type: Non-Urgent Crossing Status: Found UCIP Comments: Verify if pipe is abandoned with landowner and remove or abandon properly if necessary. FIELD_STRUCT_DESC: 3 of 3: *Abandoned* 24-inch concrete encased steel drain pipe through levee 17.0 feet below crown. Slide gate on concrete headwalls in waterward end, walkway to control gate and gate valve on landward end (ABO No. 9374, 1960). Originally included in the 1960 O&M manual. FS Date: 3/18/2013

Slide gate on WS toe.

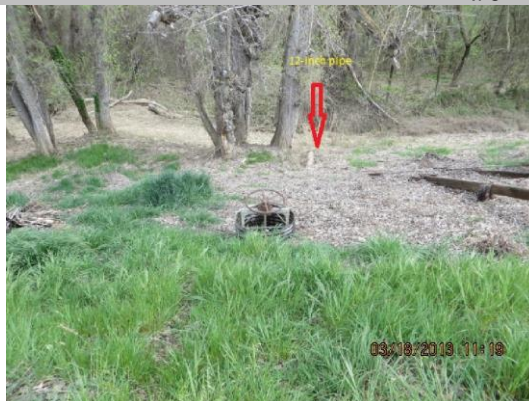
Photo 1 of 2 : UCIP_SP_2016_10444_17725.jpg

Comment Code					
Inspector Comment					
FS_ID:10444 DS_ID:20274 EP_NO: 9374 Repair Type: Non-Urgent Crossing Status: Found UCIP Comments: Pipe should be abandoned properly. FIELD_STRUCT_DESC: 4 of 4: 24-inch corrugated metal pipe through levee 15.5 feet below crown (ABO No. 9374, 1974). Two corrugated metal cutoff walls. Slide gate in 36-inch corrugated metal riser unit on the waterward slope. Pump house with no connection on waterward bank. 12-inch steel pipe with steel plate over end at WS toe (likely pump connection point). 6-foot diameter concrete riser on LS toe. Skid rails mounted on wood piling on the waterward slope. Department of Water Resources B.M. SR 47 on top of concrete anchor post on the waterward shoulder. Power pole and meter box on the waterward shoulder. Switch panel in metal house on the waterward slope. Concrete standpipe on the landward side. Overhead power line crosses the levee to service pole. FS Date: 3/18/2013 7:51:00 AM

36-inch CMP riser with slide gate on WS slope with 12-inch pipe at Toe.

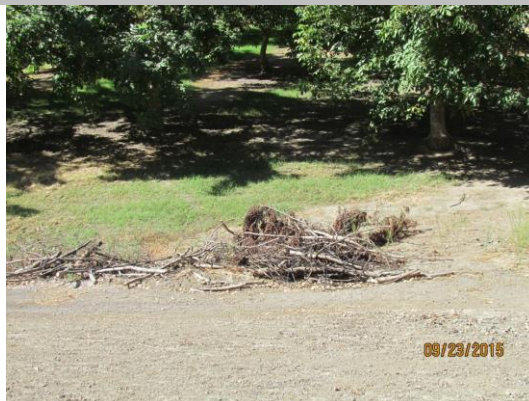
Photo 1 of 1 : SP_2016_NA0016_435_141_20160304_00078.jpg

LM Start	36.32	Rating **	M	Issue No.	141
LM End	36.32	Issue Type +	En	Location *	LS
Category	Earthen Levee			GPS Latitude/Longitude	
				Start	End
Item	Encroachments			39.113305 °	39.113305 °
				-121.913224 °	-121.913224 °
DWR ID	DWR_NA0016_01_f_2015_141				
Comment Code					
PR : Prunings					
Inspector Comment

View of the pile of prunings on the landward side of the levee. Fall 2015.

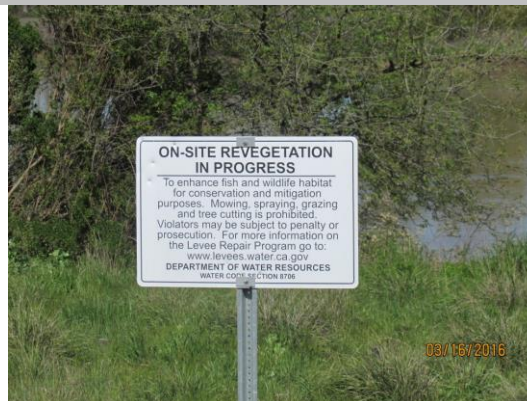
Photo 2 of 2 : SP_2016_NA0016_435_33_20160328_00277.jpg

LM Start	37.07	Rating **	A/W	Issue No.	33 (cont)	
LM End	37.15	Issue Type +	Ob	Location *	WS	
Category	Earthen Levee			GPS Latitude/Longitude		
				Start		End
Item	Vegetation			39.121003 °		39.121547 °
				-121.919888 °		-121.921278 °
DWR ID	DWR_NA0016_01_s _ 2012_33					
Comment Code						
V8 : Environmental Requirements.						
Inspector Comment						
Revegetation site is fenced off.

Sign stating the revegetation site. Spring 2016.

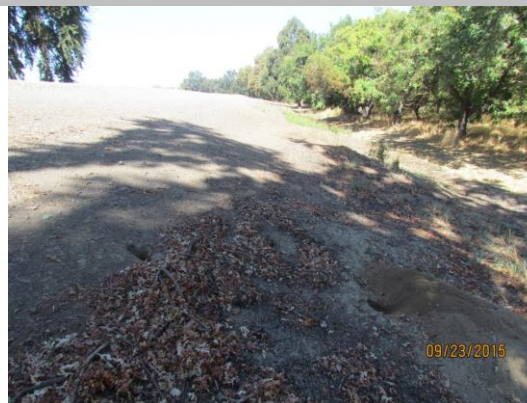
Photo 1 of 1 : SP_2016_NA0016_435_142_20160304_00079.jpg

LM Start	37.72	Rating **	M	Issue No.	142
LM End	37.72	Issue Type +	Ma	Location *	WS
Category	Earthen Levee			GPS Latitude/Longitude	
				Start	End
Item	Animal Control			39.126950 °	39.126950 °
				-121.928547 °	-121.928547 °
DWR ID	DWR_NA0016_01_f _ 2015_142				
Comment Code					
A3 : No rodents visible, but rodent burrows visible; need to backfill and compact or grout burrows.					
Inspector Comment

View of the rodent holes on the waterward side of the levee looking upstream. Fall 2015.

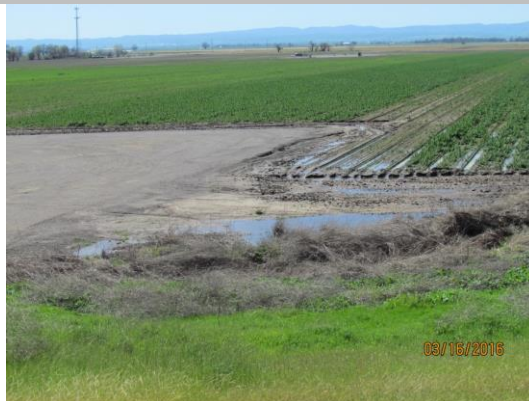
Photo 1 of 1 : SP_2016_NA0016_435_216_20160328_00278.jpg

LM Start	37.81	Rating **	U	Issue No.	216
LM End	37.81	Issue Type +	Ob	Location *	LS
Category	Earthen Levee			GPS Latitude/Longitude	
				Start	End
Item	Seepage / Sandboils			39.127945 °	39.127945 °
				-121.929831 °	-121.929831 °
DWR ID	DWR_NA0016_01_s_2016_216				
Comment Code					
Inspector Comment					
LMA is monitoring the seepage.

View of the seepage on the landward side of the levee. Spring 2016.

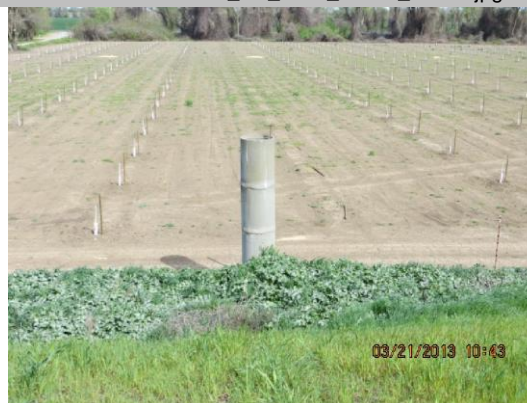
Photo 1 of 2 : UCIP_SP_2016_10528_17854.jpg

LM Start	39.93	Rating **	M	Issue No.	1580
LM End	39.93	Issue Type +	En	Location *	LS
Category	Supplemental			GPS Latitude/Longitude	
				Start	End
Item	DWR UCIP Field Study			39.143387 °	39.143387 °
				-121.927196 °	-121.927196 °
DWR ID					
Comment Code					
Inspector Comment					
FS_ID:10528 DS_ID:20282 EP_NO: 9352 Repair Type: Non-Urgent Crossing Status: Found UCIP Comments: Pipe appears to have been removed from levee section. Need to verify pipe abandonment. FIELD_STRUCT_DESC: 12-inch steel pipe through levee 5.0 feet below crown. Switch house on waterward shoulder, pump and gate valve on waterward bank. Concrete discharge standpipe on landward side. Permit was for a 14-inch (Permit No. 635, 1935). Included in the 1960 O&M manual and ABO No. 9351. FS Date: 3/21/2013

Concrete standpipe at LS toe.

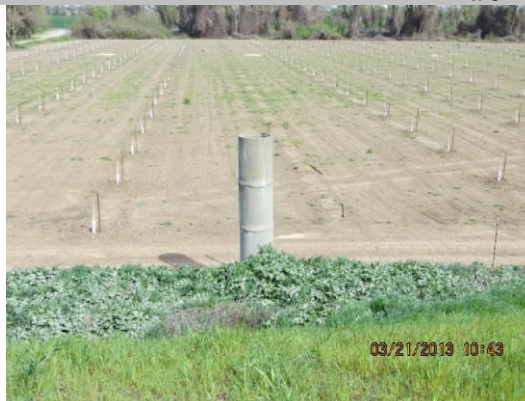
Photo 1 of 2 : UCIP_SP_2016_11343_18741.jpg

LM Start	39.93	Rating **	M	Issue No.	1556
LM End	39.93	Issue Type +	En	Location *	LS
Category	Supplemental			GPS Latitude/Longitude	
				Start	End
Item	DWR UCIP Field Study			39.143387°	39.143387°
				-121.927196°	-121.927196°
DWR ID					
Comment Code					
Inspector Comment					
FS_ID:11343					
DS_ID:22966					
EP_NO: 9352					
Repair Type: Non-Urgent					
Crossing Status: Found					
UCIP Comments: Pipe should be removed.					
FIELD_STRUCT_DESC: 1.5-inch galvanized iron electrical conduit through the levee at unknown depth. Visible on WS slope (Permit No. 635, 1935).					
FS Date: 3/21/2013

Electrical conduit approximately perpendicular to concrete riser on LS toe.

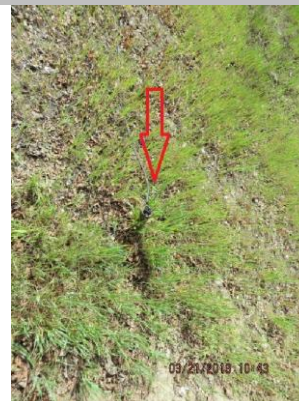
Photo 2 of 2 : UCIP_SP_2016_11343_18740.jpg

1.5-inch electrical conduit on WS slope.

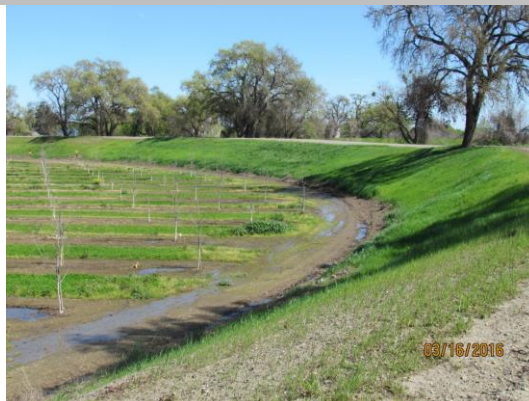
Photo 1 of 1 : SP_2016_NA0016_435_220_20160328_00279.jpg

LM Start	40.23	Rating **	U	Issue No.	220
LM End	40.29	Issue Type +	Ob	Location *	LS
Category	Earthen Levee			GPS Latitude/Longitude	
				Start	End
Item	Seepage / Sandboils			39.142304 °	39.142142 °
				-121.921861 °	-121.920833 °
DWR ID	DWR_NA0016_01_s _ 2016_220				
Comment Code					
Inspector Comment					
LMA is monitoring seepage site.

View of the seepage on the landward side of the levee looking upstream.
Spring 2016.

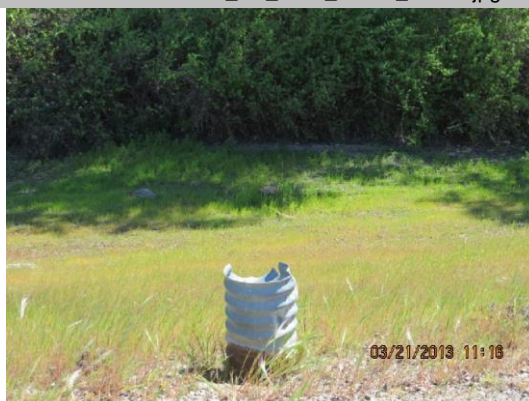
Photo 1 of 2 : UCIP_SP_2016_10527_17850.jpg

LM Start	40.44	Rating **	M	Issue No.	1579
LM End	40.44	Issue Type +	En	Location *	LS
Category	Supplemental			GPS Latitude/Longitude	
				Start	End
Item	DWR UCIP Field Study			39.143838 °	39.143838 °
				-121.919338 °	-121.919338 °
DWR ID					
Comment Code					
Inspector Comment					
FS_ID:10527					
DS_ID:20285					
EP_NO: 12799					
Repair Type: Non-Urgent					
Crossing Status: Found					
UCIP Comments: Pipe appears abandoned. Need to verify type of abandonment					
FIELD_STRUCT_DESC: 18-inch steel pipe through levee 6.5 feet below crown. 30-inch CMP standpipe on LS toe. Pump on the waterward toe. Vent in 12-inch CMP riser on the WS shoulder. (Permit No. 12799, 1979).					
FS Date: 3/21/2013

Vent in 12-inch CMP riser on WS shoulder.

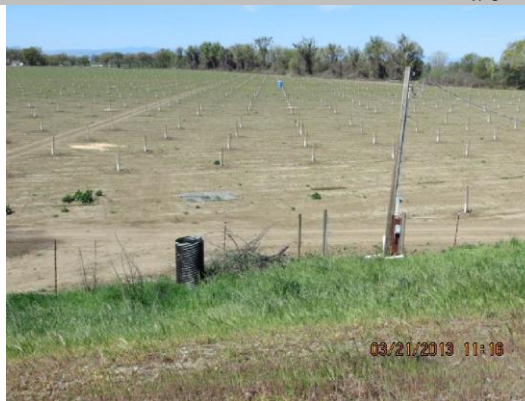
Photo 2 of 2 : UCIP_SP_2016_10527_17849.jpg

LM Start	40.44	Rating **	M	Issue No.	1579 (cont)
LM End	40.44	Issue Type +	En	Location *	LS
Category	Supplemental			GPS Latitude/Longitude	
				Start	End
Item	DWR UCIP Field Study			39.143838 °	39.143838 °
				-121.919338 °	-121.919338 °
DWR ID					
Comment Code					
Inspector Comment					
FS_ID:10527					
DS_ID:20285					
EP_NO: 12799					
Repair Type: Non-Urgent					
Crossing Status: Found					
UCIP Comments: Pipe appears abandoned. Need to verify type of abandonment					
FIELD_STRUCT_DESC: 18-inch steel pipe through levee 6.5 feet below crown. 30-inch CMP standpipe on LS toe. Pump on the waterward toe. Vent in 12-inch CMP riser on the WS shoulder. (Permit No. 12799, 1979).					
FS Date: 3/21/2013

30-inch CMP riser with slide gate at LS toe.

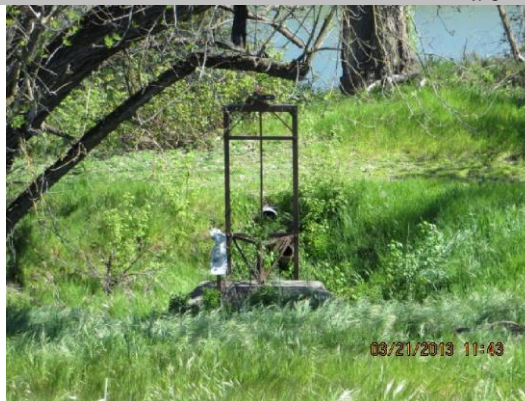
Photo 2 of 2 : UCIP_SP_2016_10533_17864.jpg

LM Start	40.89	Rating **	M	Issue No.	1585 (cont)	
LM End	40.89	Issue Type +	En	Location *	WS	
Category	Supplemental			GPS Latitude/Longitude		
				Start	End	
Item	DWR UCIP Field Study			39.150054 °	39.150054 °	
				-121.918717 °	-121.918717 °	
DWR ID						
Comment Code						
Inspector Comment						
FS_ID:10533						
DS_ID:20287						
EP_NO: 9351						
Repair Type: Non-Urgent						
Crossing Status: Found						
UCIP Comments: Appears abandoned. Should be abandoned properly.						
FIELD_STRUCT_DESC: 30-inch corrugated metal pipe through levee						
17.5 feet below crown. Slide gate on the waterward end. Discharges						
into concrete box at the landward toe (ABO No. 9351, 1960). Small						
pump discharges into sump area in front of slide gate at WS toe.						
FS Date: 3/21/2013

Slide gate at WS toe.

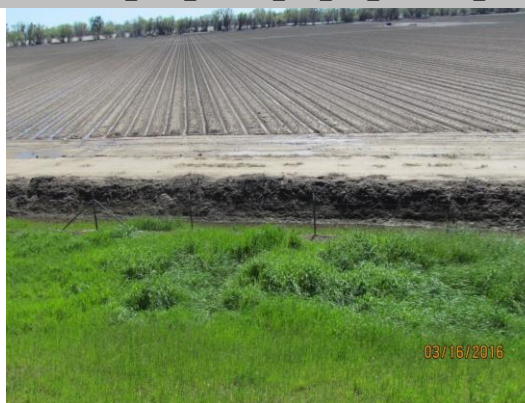
Photo 1 of 1 : SP_2016_NA0016_435_222_20160328_00280.jpg

LM Start	41.60	Rating **	U	Issue No.	222
LM End	41.64	Issue Type +	Ob	Location *	LS
Category	Earthen Levee			GPS Latitude/Longitude	
				Start	End
Item	Seepage / Sandboils			39.156913 °	39.157074 °
				-121.928324 °	-121.928964 °
DWR ID	DWR_NA0016_01_s_2016_222				
Comment Code					
Inspector Comment					
Seepage is being monitored by LMA.

View of the seepage in the ditch at the toe of the levee on the landward side. Spring 2016.

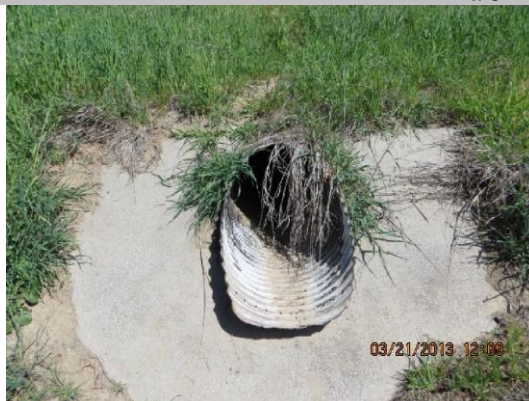
Photo 1 of 2 : UCIP_SP_2016_10536_17883.jpg

FS_ID:10536
DS_ID:20289
EP_NO: 9341
Repair Type: Non-Urgent
Crossing Status: Found
UCIP Comments: Appears abandoned. Needs to be abandoned properly.
FIELD_STRUCT_DESC: 30-inch pipe through levee 19.5 feet below crown. Slide gate in 36-inch corrugated metal pipe riser on the waterward slope (ABO No. 9341, 1960)
FS Date: 3/21/2013

30-inch CMP at outlet on LS toe.

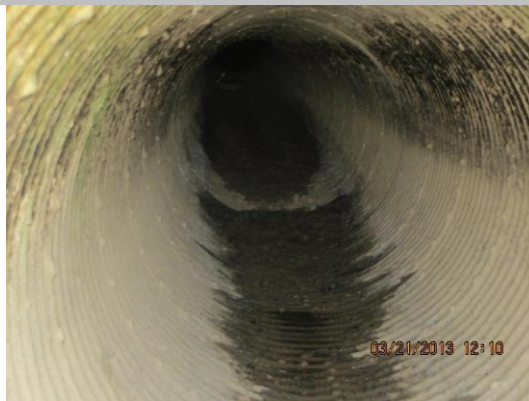
Photo 2 of 2 : UCIP_SP_2016_10536_17882.jpg

View from LS toe of CMP pipe.

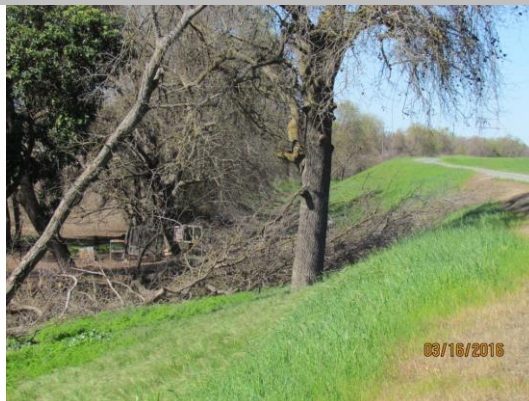
Photo 1 of 1 : SP_2016_NA0016_435_223_20160328_00281.jpg

LM Start	42.22	Rating **	M	Issue No.	223
LM End	42.22	Issue Type +	Ma	Location *	LS
Category	Earthen Levee			GPS Latitude/Longitude	
				Start	End
Item	Encroachments			39.162903 °	39.162903 °
				-121.936042 °	-121.936042 °
DWR ID	DWR_NA0016_01_s_2016_223				
Comment Code					
TR : Tree or limb					
Inspector Comment

View of the fallen tree on the landward side of the levee looking upstream. Spring 2016.

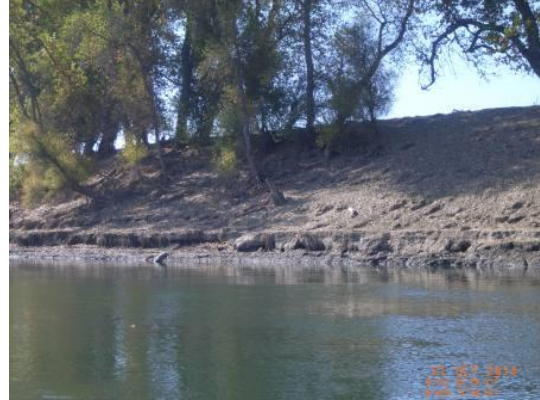
Photo 1 of 1 : SP_2016_NA0016_435_4_20160304_00004.jpg

LM Start	42.90	Rating **	A/W	Issue No.	4
LM End	43.09	Issue Type +	Ma	Location *	WS
Category	Supplemental			GPS Latitude/Longitude	
				Start	End
Item	2015 USACE Erosion Survey, DRAFT			39.172501 °	39.174949 °
				-121.939053 °	-121.940737 °
DWR ID	DWR_NA0016_01_s_2016_4				
Comment Code					
Inspector Comment					
2010 - Lower portion of 136.7 that did not extend far enough. Abrupt transition from upstream site. 2012 - Site extended upstream, minor new erosion. 2013 - Minor new erosion at the toe. New tree popout. Downstream limit extended. 2015: No observed changes. [2015 Site ID: SAC_136-6_R]
